Survey of Northern damselfly (*Coenagrion hastulatum*) management sites and new ponds

Stephen Corcoran
Director
Corcoran Consultants
January 2024

To undertake field surveys of 12 Northern damselfly ponds where management works were undertaken in 2022 and survey 11 new ponds that were created in 2022. Record odonata present at each site and make any further recommendations for future management and pond construction design.

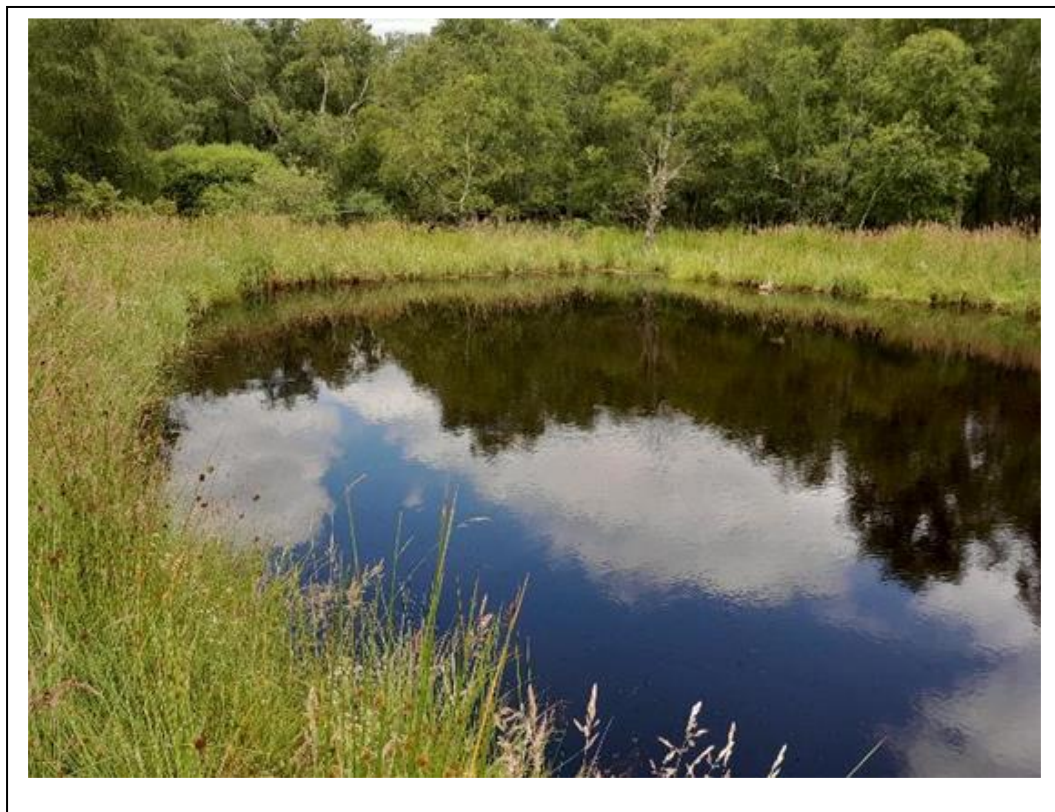
Insh
Soillerie
lower
pond

This is a new pond constructed in early 2022 in an area of rush and sedges, feed by a small burn. It is a good size, shaped like 2 circles stuck together at 10m by 21m giving an area of approximately 195m². Has deep edges and looks more than 1.5m deep in middle. There was a high water level despite recent dry conditions.

Already there is a small fringe of emergent vegetation developing made up of sedge and rush. There is no floating vegetation though the burn flowing in has some pondweed and horsetails. The banks are dominated by rush with some sedge, horsetail, sphagnum, water-forget-me-not, grasses and plus occasional thistle, nettle, and buttercup. There is a diverse invertebrate community including pond skaters, water boatmen, water beetles, and spiders. Palmate newt efts were also present.

Five out of the six species of damselfly that breed in Strathspey were seen on the pond, with evidence of breeding activity for all five of these including Northern damselfly. Four species of dragonfly were also present. This is a good range of Odonata species for a pond less than 18 months old. This is already looking well naturalised and is a good example of the kind of pond that can be created to benefit Odonata.

Management Recommendations: None; continue surveys to determine size of Northern damselfly population.

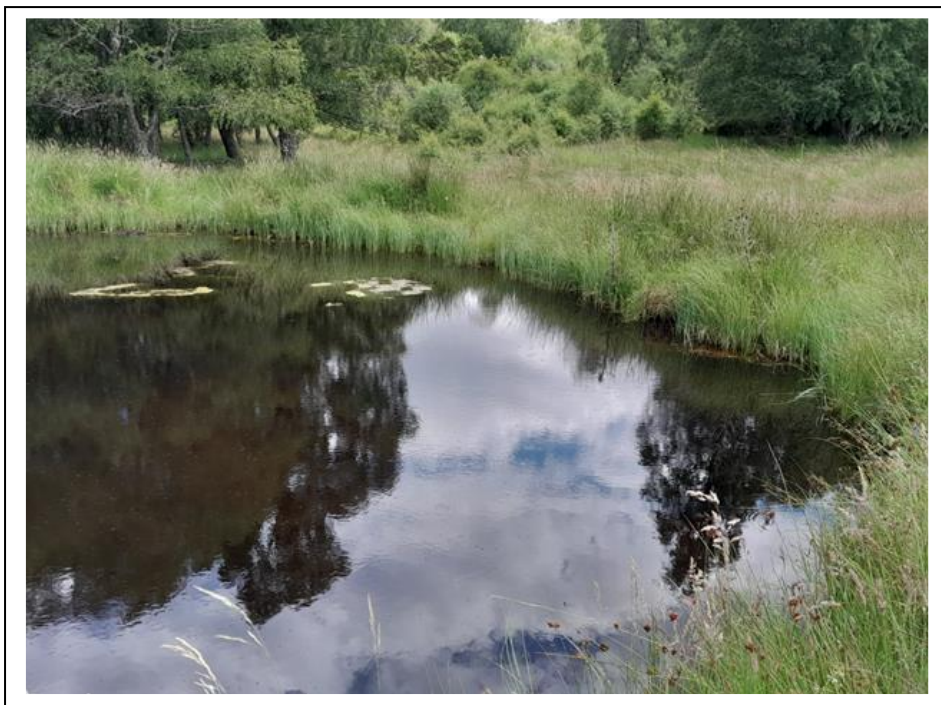
Insh Soillerie upper pond

A new pond constructed in early 2022 in a wet hollow in an area of rush and sedges, fed by a small burn. It is a good size, 13m by 21m giving an area of approximately 270m². Has deep edges and looks more than 1.5m deep in middle. Had a high water level despite recent dry conditions.

Already there is a fringe of emergent vegetation developing including sedges, rush and horsetails and a small amount of pondweed is also present in the pond. The banks are dominated by rush with some sedge, horsetails, sphagnum, cotton grass, water-forget-me-not, grasses and thistles plus occasional orchids, nettle, and buttercup. There is a diverse invertebrate community including pond skaters, water boatmen, water beetles, and spiders. Palmate newt efts were also present.

All six species of damselfly that breed in Strathspey were seen on the pond, with evidence of breeding activity for five of these including a very small instar Northern damselfly larvae. Four species of dragonfly were also present, with evidence of breeding for one. This is an exceptional range of Odonata species for a pond less than 18 months old.

This is already looking well naturalised and is another excellent example of the kind of pond that can be created to benefit Odonata.

Management Recommendations: None; continue surveys to determine size of Northern damselfly population.

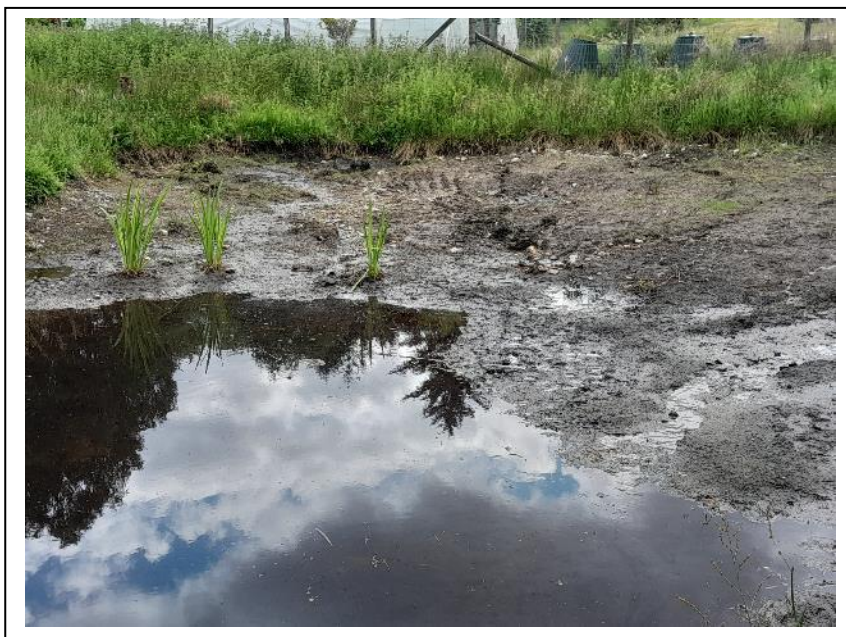
The Old School Insh Pond

Dug out in early 2023 in an area of grassland and open birchwoods, this cone-shaped pond is 16m long and 6m across at its widest point covering an area of around 75 square metres. There is a large area, around 100m², that was dug out but is just bare earth. The pond edges are reasonably deep around 50cm at the NW end of the pond becoming shallower towards the south. It looked about 1m deep and is fed by a small spring.

The pond design and construction failed to understand the slope present on the site meaning the SE area will always remain dry. Water level in the pond looked a little low reflecting the recent spell of very dry weather.

There was no emergent vegetation round the pond and the banks contained large patches of bare earth. There was no floating vegetation in the pond. Around the banks were some docks, grasses, willowherb, rush, and meadowsweet. 3 small iris plants had been introduced to the pond edge.

There was a modest invertebrate community including pond skaters, water boatmen, water beetles and spider; most were early life stage; Palmate newt efts were also present. Domestic and wild ducks were present and could be a negative influence on pond water chemistry and biodiversity.

Management Recommendations: ideally dig the SE part of the pond to a deeper depth, probably to at least 1m. And discourage the domestic ducks from using the pond.

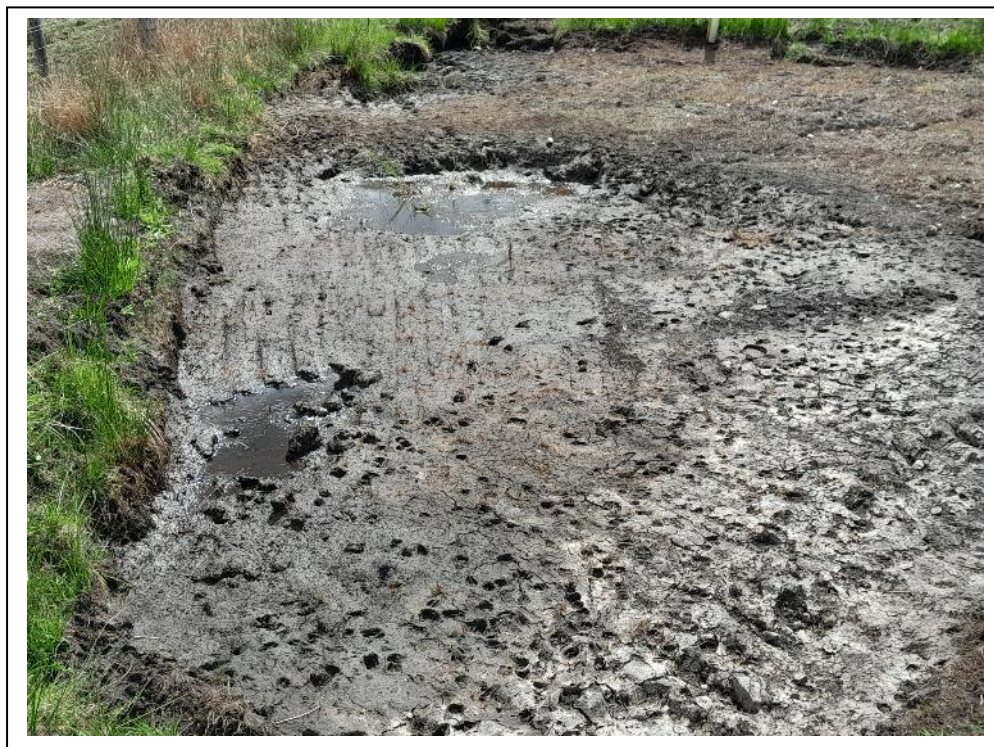
Insh
Community
Woods
pond

Another, small pond dug in early 2023 in a rushy area of croft grassland. The total pond is 136m², roughly triangular about 11-12m across. When it was visited, it was nearly dried out with just 2 very small patches of water left (each about 1m²).

The pond is poorly constructed, with not enough attention to the site gradient. A large area was dug out but is on a slope and is not deep enough to hold any water due to the gradient. The lower part of the pond, perhaps some 45m², will hold water during wet periods and is likely to nearly dry out as was observed on the first visit in June. The low bund that keeps water levels higher is already leaking and is likely to fail further reducing water levels.

There were no emergent plants or floating vegetation in or around the pond. Most of the pond is just bare earth, with only partly vegetated banks with patches of earth. On the banks there were some rush, grasses, thistle, buttercup, and nettle. The 2 small patches of water contained a few pond skaters, water beetles and water boatmen. Common frog tadpoles and froglets were seen in these small pools.

Management recommendations: dig out the pond to a much deeper depth, with deeper banks and use spoil to build up the bund on the eastern side along the fence to create a higher and more effective dam.

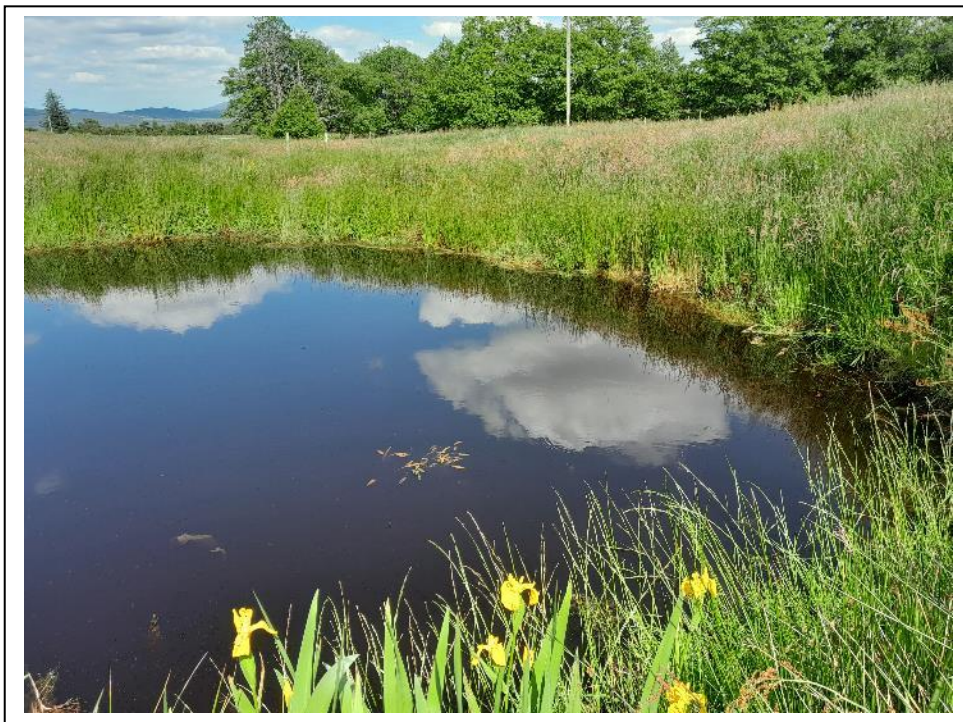
Lynamer west pond

Two ponds were created on this croft in late 2022, very close together, only 4m apart in an area of grassland adjacent to Abernethy Forest. This pond is around 178m², 11m wide by 16m roughly rectangular in shape. It has steep banks into deep water (>70cm) and the pond must be over 2m deep. It had a high water table despite recent drought and is possibly fed by an old field drain in normal rainfall conditions.

The banks were well vegetated with grass, rush, flag iris, willowherb, and a little buttercup and dock. Emergent vegetation included flag iris, rush, lesser spearwort, and marsh cinquefoil. There was a small patch of pondweed on the surface of the pond. The steep banks and areas of floating vegetation made it difficult to net and survey a large part of the pond.

The pond had a diverse and abundant invertebrate community including pond skaters, water beetle, and water boatmen. There were large numbers of Palmate newt efts in the pond. For a new pond, there were plenty of Odonata on the wing including Northern damselfly, with a pair in tandem observed over the pond.

This is already looking well naturalised and is a good example of the kind of pond that can be created to benefit Odonata.

Management Recommendations: None; continue surveys to determine size of Northern damselfly population.

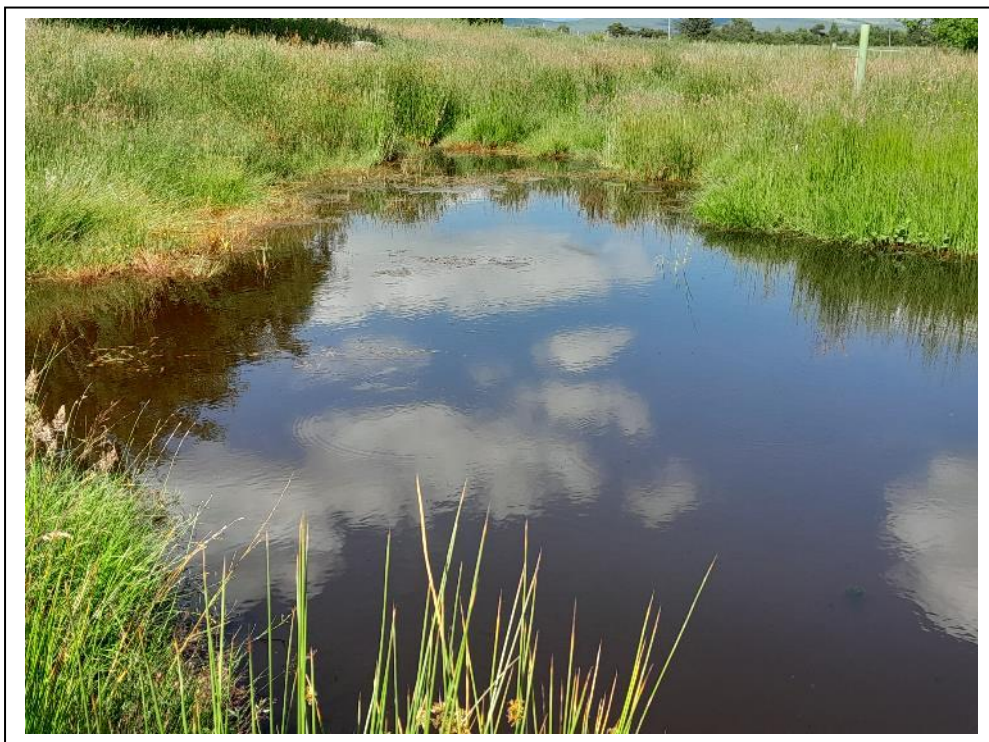
Lynamer east pond

The banks were well vegetated with grass, rush, dock, buttercup, birds-foot trefoil, marsh marigold, sphagnum, and flag iris. Emergent vegetation included flag iris, rush, lesser spearwort, sphagnum, marsh marigold and marsh cinquefoil. There were several small patches of pondweed on the surface of the pond. The steep banks and areas of floating vegetation made it difficult to net and survey a large part of the pond.

The pond had a diverse and abundant invertebrate community including pond skaters, water beetle, and water boatmen. There were large numbers of Palmate newt efts in the pond.

For a new pond, there were plenty of Odonata on the wing including Northern damselfly observed over the pond.

This is already looking well naturalised and is a good example of the kind of pond that can be created to benefit Odonata.

Management Recommendations: None; continue surveys to determine size of Northern damselfly population.

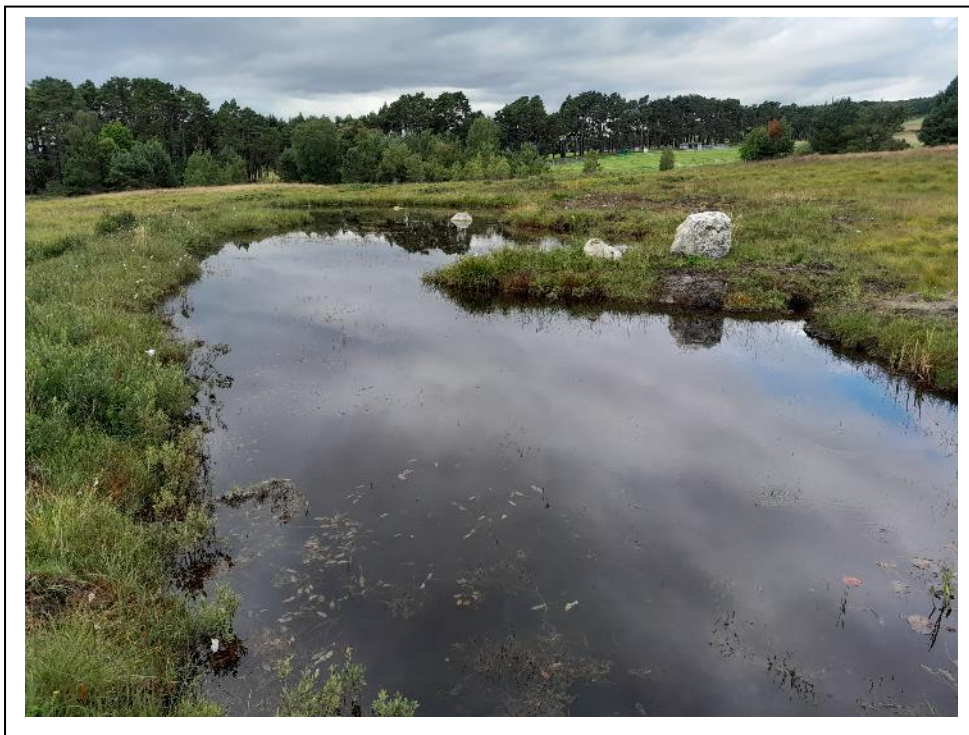
Lower
Balnacruie
pond 1

The pond had a diverse and abundant invertebrate community including pond skaters, water beetle, and water boatmen.

Another new pond with a super diversity of seven Odonata species, with breeding evidence for six species. A single Northern damselfly was seen on this pond, a new site for this part of Strathspey. There are 2 existing ponds 100m away from this pond that were surveyed. These ponds are maybe about 20 years old, put in by the existing owners, and these also contain Northern damselfly making this a new colony for the species.

Management Recommendations: None; continue surveys to determine size of Northern damselfly population.

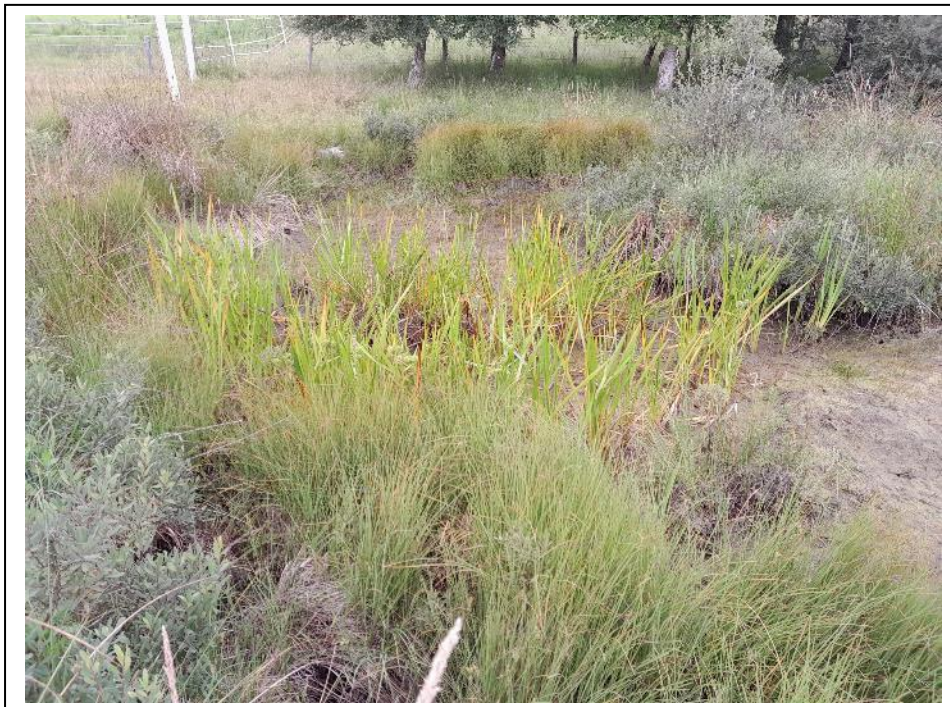
Lower Balnacruie pond 2

There was pondweed in the middle, damp part of the pond, with the edges having flag iris, rush, sedge, and bog myrtle. On the banks were rush, bog asphodel, bog myrtle, thistle, tormentil, sedge, and grass,

The pond was completely dry when it was visited in July, and the drain was dry. It should have been dug deeper by at least 50cm, with slightly deeper sides and the exit drain blocked with a small dam

Management recommendations: dig out the pond to a much deeper depth, with deeper banks and use spoil to build up the bund on the drain exit to dam the outflow. Alternatively, build up a dam on the exit drain to just maintain water levels.

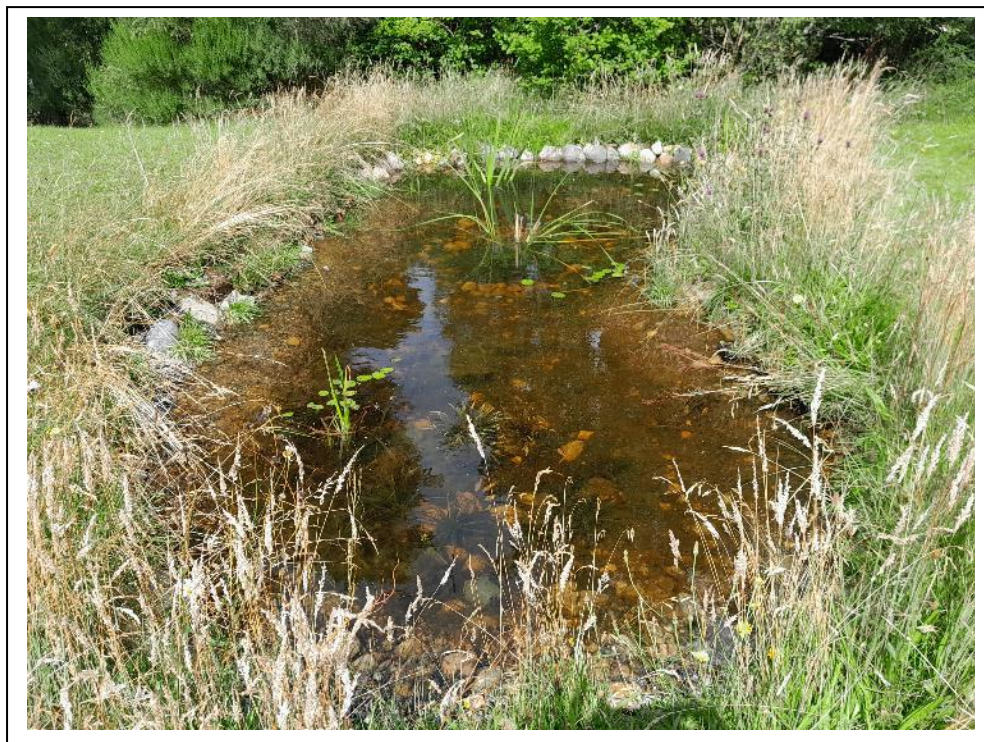
Mountview
Hotel pond

Two late instar Northern damselfly larvae were found, too advanced for the age of the pond (only a year). There was also a single palmate newt eft, and guests at the hotel had seen 2 Northern damselfly adults flying round the pond in June. The Northern damselfly are likely to have been introduced to the pond as plants were taken from a large garden pond in Nethy Bridge that is a known breeding site for the species.

Management Recommendation: a slightly deeper and bigger pond would have been more beneficial; the size was constrained by the hotel's wildflower meadow. Continue surveys to determine if the pond can support a viable Northern damselfly population.

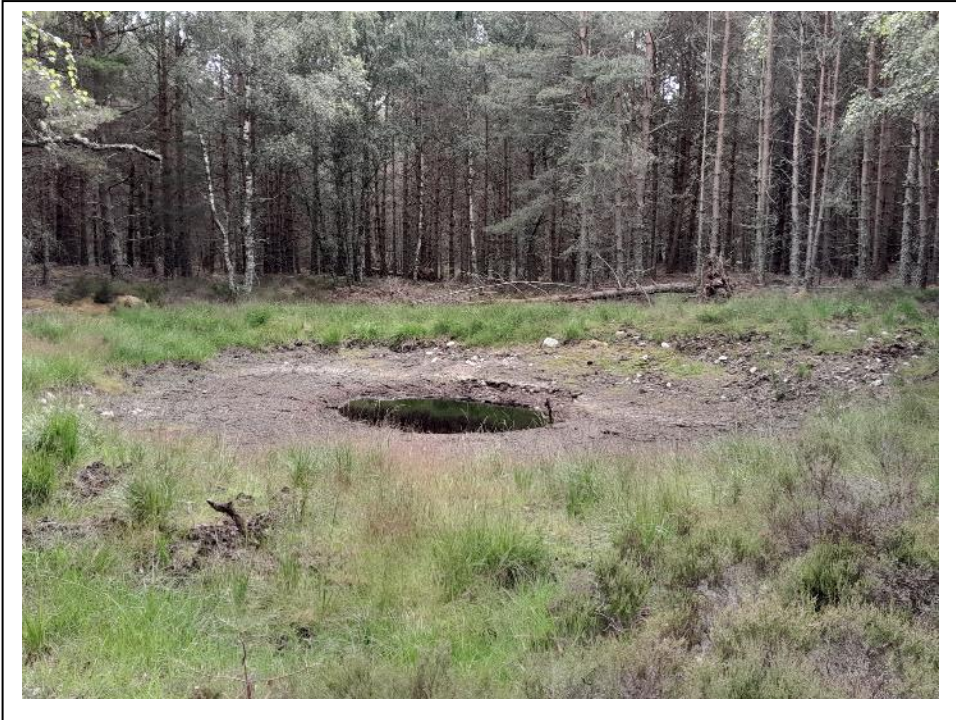
Betty's new pond

There was only a small pool of water left in the pond, maybe 3x3 metres and only around 50-70cm deep. The pond had not been dug out enough, particularly on the south side, and the whole south side will never hold water as it is much higher than the rest of the pond.

A single Black darter larva and a Palmate newt eft were found in the small pool left in the middle of the pond.

Management recommendations: Needs to be dug deeper, especially to south with particular attention to the level of the pond so that it can fill with water. A 5-metre strip of pine trees to the south of the pond could be felled to let in more light. Given the absence of any nearby wetland vegetation, material could be taken from the nearby ponds and translocated to this new pond.

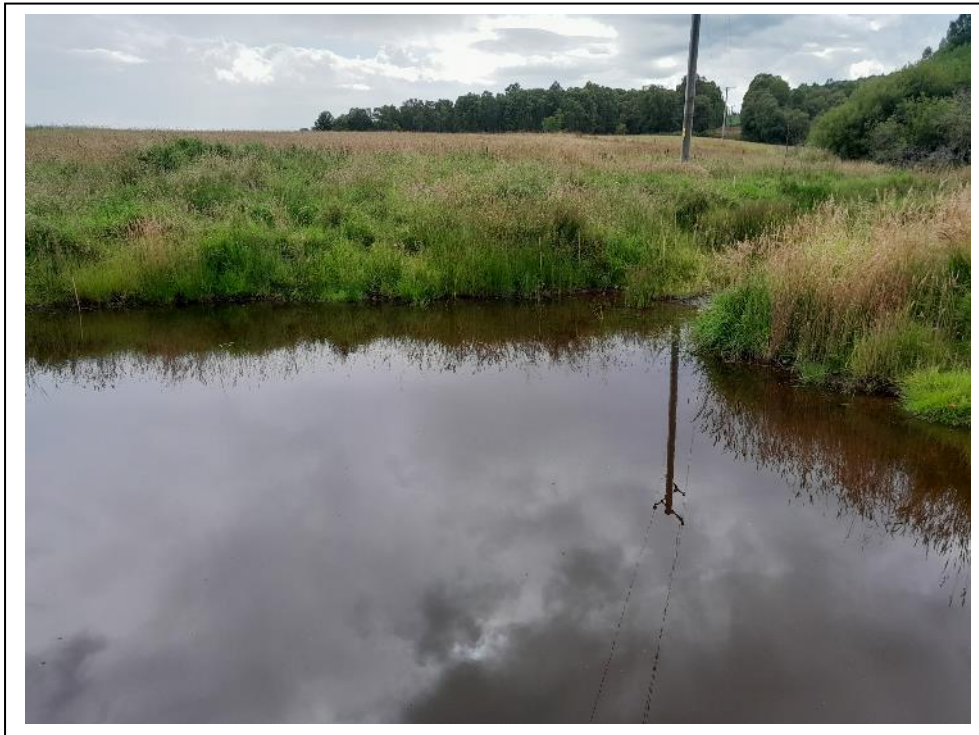
Wreaton Farm pond 2

A network of 5 small ponds built in late 2022 along the line of a small burn. This had been a canalised channel and is now re-meandered with each pond being between 40-60m². The ponds were a mixture of depths, some quite shallow <50cm others over 100cm deep, only 1 or 2 metres apart connected by the burn.

There was very limited wetland vegetation, some rush and horsetails with the bank containing grasses, rush, nettles, thistle, dock, and a few horsetails. A good, diverse community of invertebrates including water beetle, water boatman, pond skaters, mayfly, and others. The two deeper ponds to the east were better.

Five species of damselfly were recorded, with breeding for 3 confirmed. No Northern damselfly were seen and this site (and the adjacent old mill pond) are not known sites for Northern damselfly.

A good example of re-naturalising a burn with the inclusion of the ponds. The ponds could perhaps have been a little bigger and deeper. These were created with funding from Northwoods and not the BDS.

Management Recommendations: None; continue surveys to determine diversity of damselfly populations.

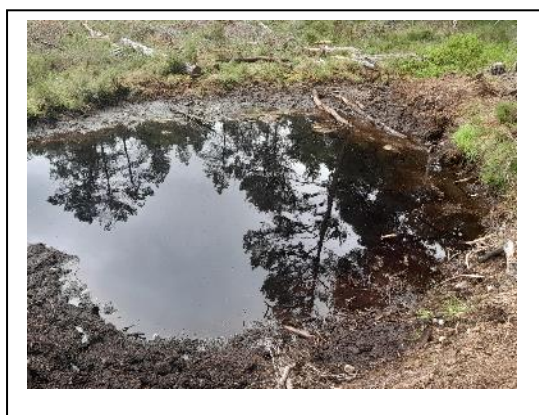
Anagach Woods fire pit pond 2 NJ03942723 [Existing]

The old fire pond was dug out and a smaller area adjacent dug out to create an enlarged pond of around 30m². A very peaty pond adjacent to bog woodland and not Northern damselfly habitat, with no records from this area of Anagach.

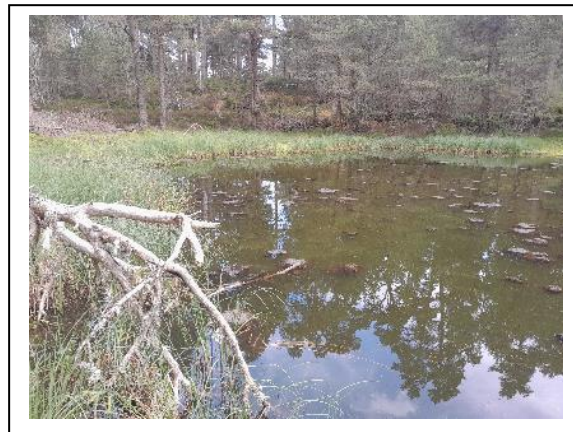
Once a large lochan, now much reduce due to succession and drainage. It is surrounded by dense reeds making access very difficult. The lochan is around 500m², at least 20 – 25m across. Some management work in early 2022 had cut a path through the dense reeds to access the pond edge. This path has now vanished, having quickly grown back. It is too difficult to access the pond edge due to dense reeds and deep water.

Through binoculars, from almost at the edge of the lochan it could be seen that the lochan has a fringe of sedges on the eastern/SE edge with water lily and pondweed on the surface. Large red damselfly was seen along with nearly 20 blue damselflies. The blue-green damselfly was just too far away to positively identify but was probably Northern damselfly.

Management recommendations: none, monitoring only.

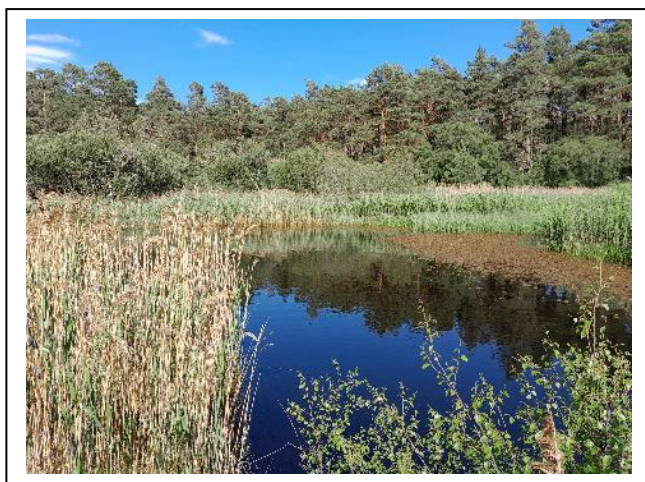
The pond is much improved with a fringe of emergent vegetation establishing and a diverse aquatic invertebrate community present. No Northern damselfly were recorded at the pond only Large red damselfly, Southern hawker and Four spotted chaser plus palmate newt efts.

Management recommendations: cut back a little more trees to the south and continue surveys to determine presence of Northern damselfly.

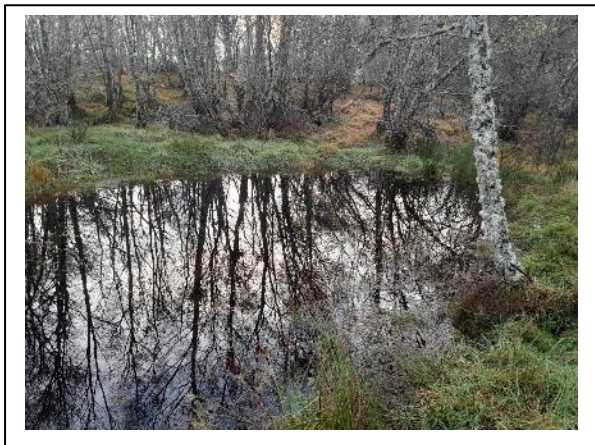
It is very shaded from the dense trees, shallow and part has infilled with vegetation. A single Large red damselfly larva and a Palmate newt eft was found. Northern damselfly has not been recorded at this pond.

Management recommendations: cut back a lot more trees to the south and thin out round rest of the pond. Dig out and make deeper an area to the NE; continue surveys to determine if Northern damselfly present.

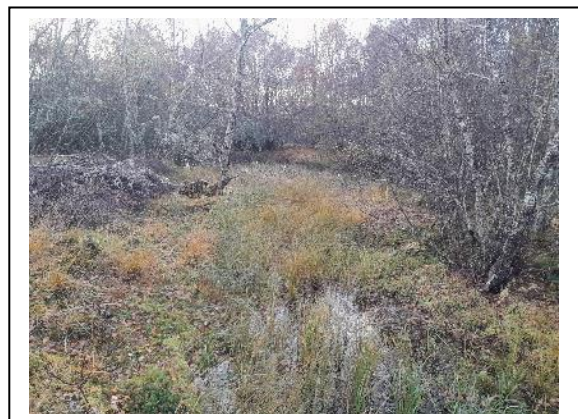
Saltstore pond, Dinnet NJ43120213 [Existing]

A large pond, around 750m², with areas of floating sphagnum and islands. Some birch and pine cut down in 2022 to create a bit more open areas. It lies within a SSSI and there were restrictions on the management works that could be carried out.

Management Recommendations: undertake periodic removal of tree regeneration every 5 years.

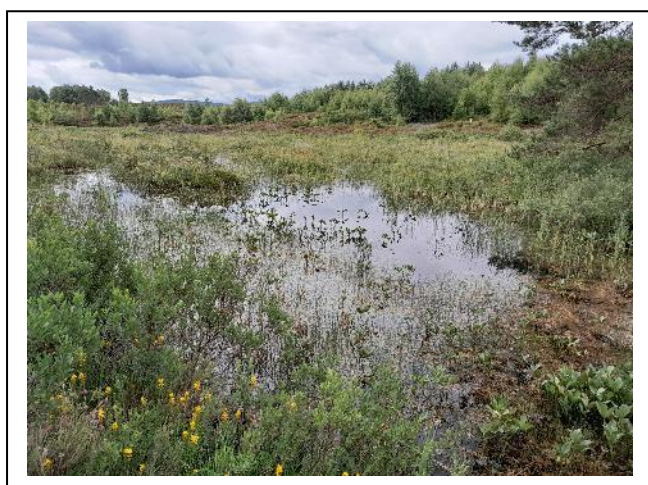
Betty's pool, Dinnet NJ433701894 [Existing]

A large pond, around 800m², with areas of floating sphagnum and islands. Some birch and pine cut down in 2022 to create a bit light plus a small drain blocked with turf (it lies within a SSSI and there were restrictions on the management works that could be carried out). Water level looked lower than normal. Some areas of bare peat/silt with no water. Quite shaded by tall pine to south.

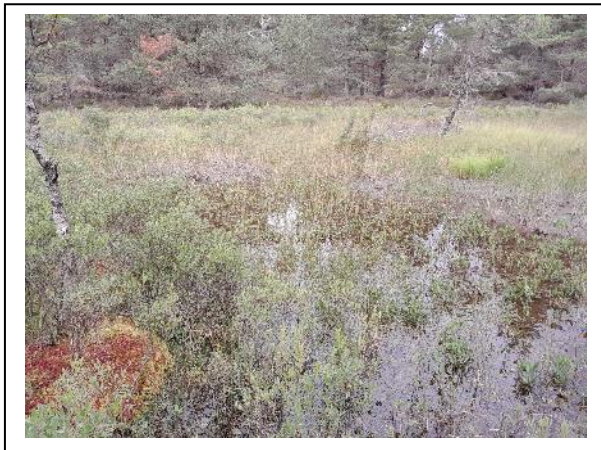
An old curling pond, 630m², completely dominated by sedges with very little open water. Management in 2022 cleared some trees and scrub. Some rush, pondweed and spiked... around the edges. Bank dominated by birch and willow, very thick in places, along with grass, wood rush, ferns, bracken, brambles, foxglove, and nettle.

Water quite shallow, well below normal level and in some places only 10-20cm deep. Very difficult to access pond due to thick scrub and steep banks. Saw many blue damselflies but could not ID them. Good aquatic invertebrate communities present.

Management recommendations: cut back scrub and trees on southern side and dig out a third of pond to create an area of deeper, open water.

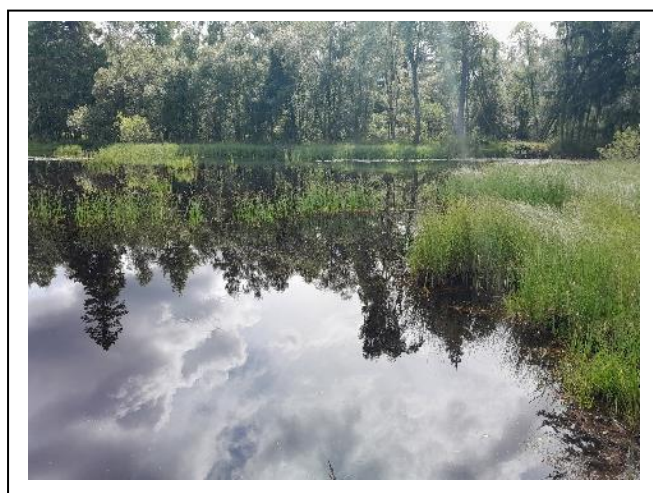
Mark Tasker passed on records for this pond from 26/06/23 when he saw large numbers of Emerald, Large Red and Common blue damselflies with only small numbers of Northern damselfly. There were also large numbers of Four-spotted chasers present.

Management recommendations: a few more of the larger trees to the south could be removed to improve sunlight into the pond. Undertake periodic removal of spruce regeneration. Monitor Northern damselfly populations to see if any changes given high numbers of Common blue and recent colonisation by Azure damselfly.
