## **GALLOWS CROSS SUDS PONDS, KINGSTEIGNTON**

# 2017-2026: Confirmed Priority Site of Local Importance

Last updated: 29/03/2025

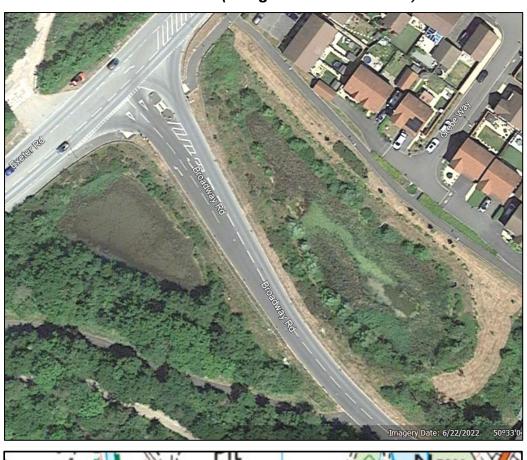
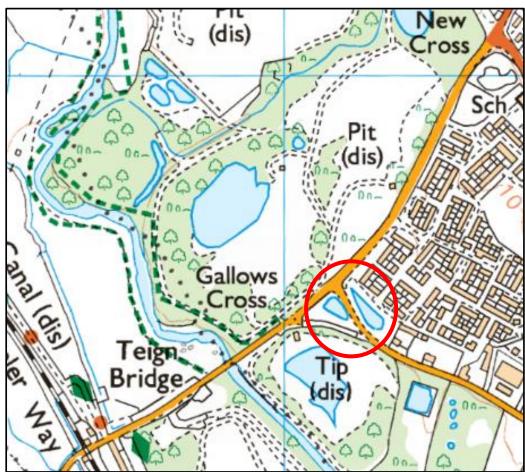
Gallows Cross SUDS Ponds (Google Earth 22/06/2022)

Two permanently wet SuDS (Sustainable Drainage System) ponds created to collect rainwater and sediment from adjacent housing estate (on site of former New Cross Pond DWT Reserve), situated either side of diverted Broadway Road. Their close proximity to several old and new ponds related to ball clay extraction ensured rapid colonisation of dragonflies. Access impossible in early years until 2017. Peripheral growth of planted shrubs hampered observations considerably by 2024.

**Western Pond**: quickly established fringing emergents (*Phragmites* and *Typha*) and submerged aquatics, with almost total cover of *Myriophyllum spicatum* by 2024; some turbidity caused by introduced carp.

**Eastern Pond**: dominated by *Phragmites* and *Typha*, with essentially no open water by 2024, despite removal of some sediment (winter 2021/22?).

- Successional development, causing loss of open water.
- Predation and turbidity from introduced carp.

- Maintain areas of open water by periodic dredging.
- Create/maintain observation viewpoints.
